Zaporozhe NPP

Fire Protection Coating of Structural steelwork in the turbine hall, Projects TACIS 1993 U1.03/93B, U1.03/94A, U1.03/95A, TACIS 1995 U1.03/95A1

Nuclear power plant	Zaporozhe NPP, Ukraine
Project reference	U1.03/94A
Project name	Zaporozhe Fire Protection Equipment,
IAEA safety issue	IH 2
Safety rank	III
Budget year	1993,94,95
Contract amount, Euro	2,948,214
EC endorsement of the contract	05.06.1996
Supplier	SVT
Current status of the project	Completed
Provisional acceptance certificate	08.12.1997

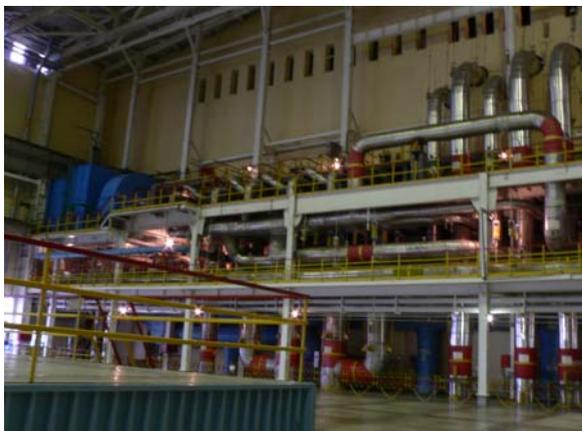
Fig. 3 Present view of the turbine hall - walls with fire resistant coating

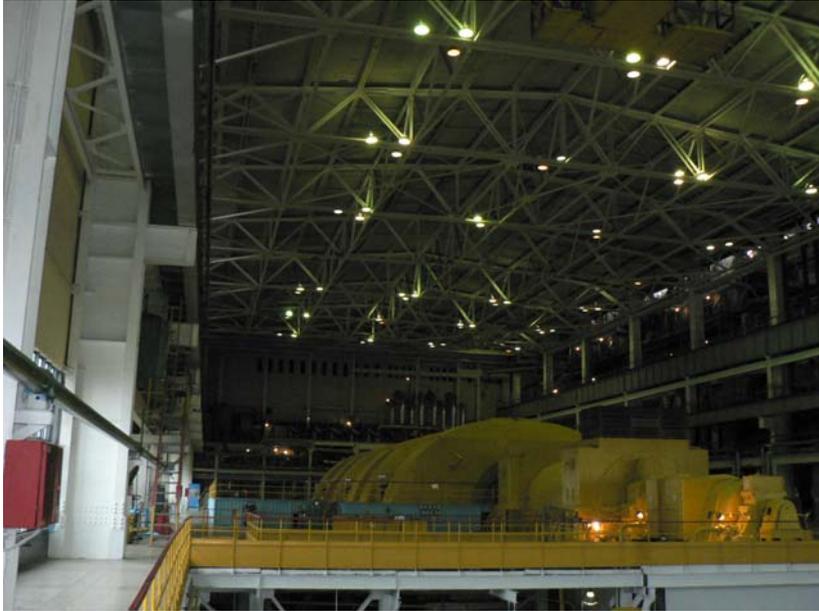
Fig. 4 Turbine hall - on the left a column with fire resistant coating

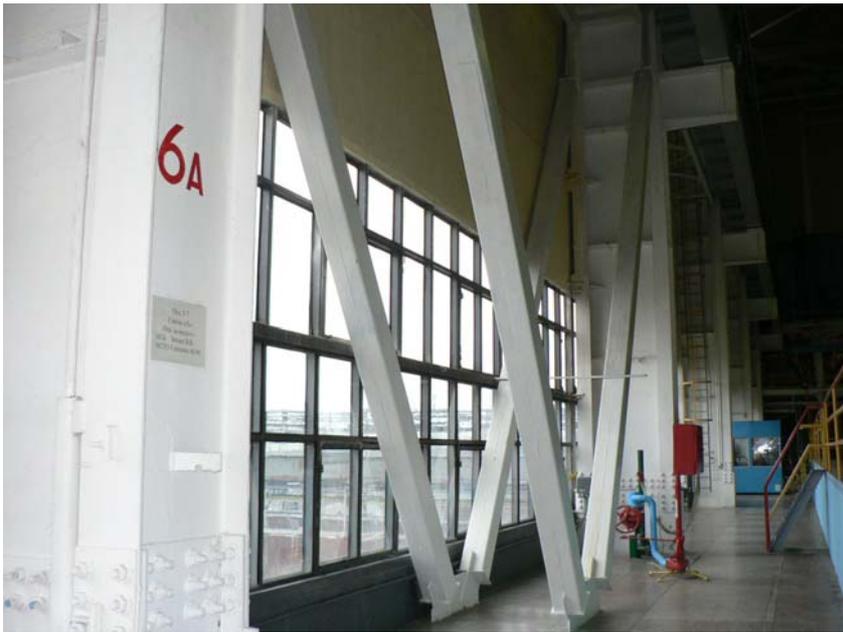
Fig. 5 Support columns in the turbine hall coated with fire resistant layers.

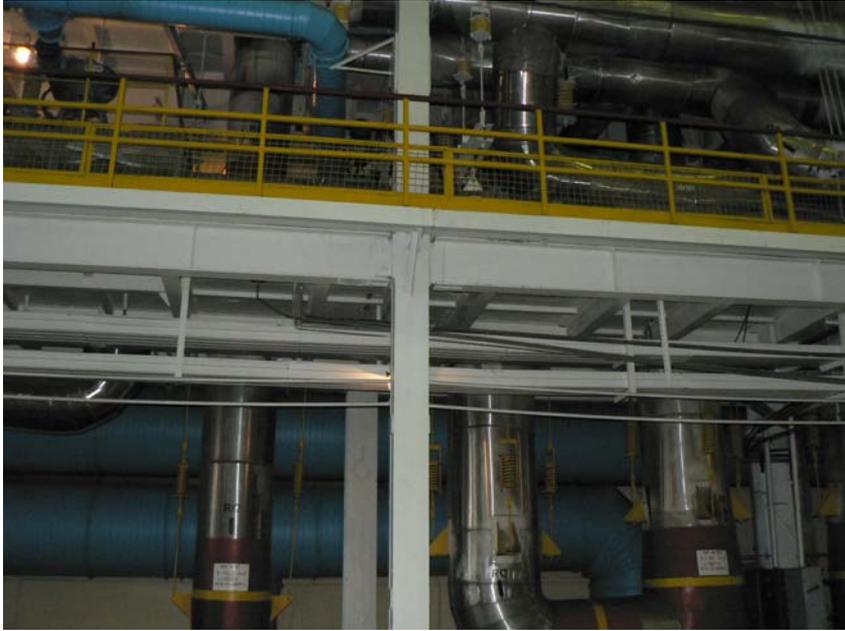
Structures in the turbine hall with fire resistant coating

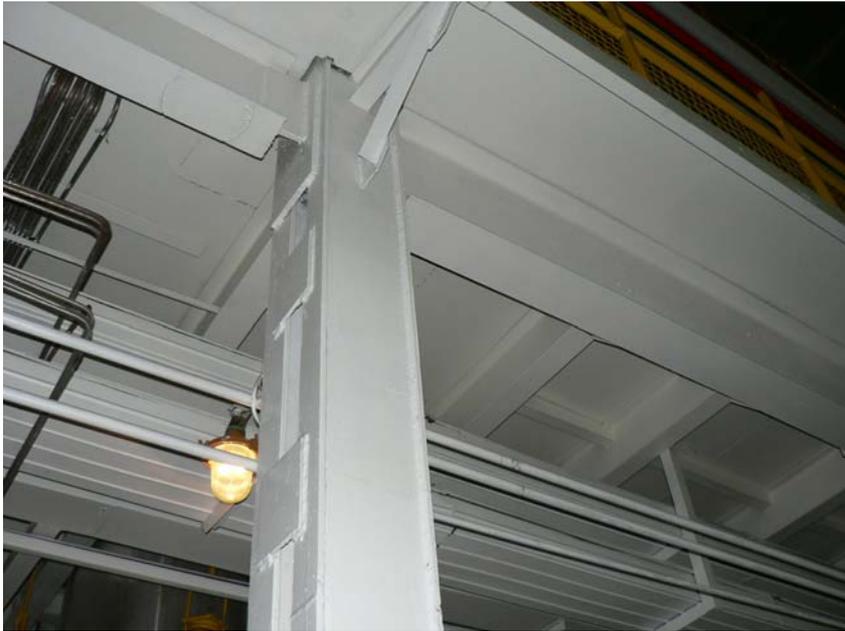
Structures in the turbine hall covered with fire resistant coating
