Zaporozhe NPP

Fire Protection Coating of Structural steelwork in the turbine hall, Projects TACIS 1993 U1.03/93B, U1.03/94A, U1.03/95A, TACIS 1995 U1.03/95A1

Nuclear power plant	Zaporozhe NPP, Ukraine
Project reference	U1.03/94A
Project name	Zaporozhe Fire Protection Equipment,
IAEA safety issue	IH 2
Safety rank	III
Budget year	1993,94,95
Contract amount, Euro	2,948,214
EC endorsement of the contract	05.06.1996
Supplier	SVT
Current status of the project	Completed
Provisional acceptance certificate	08.12.1997

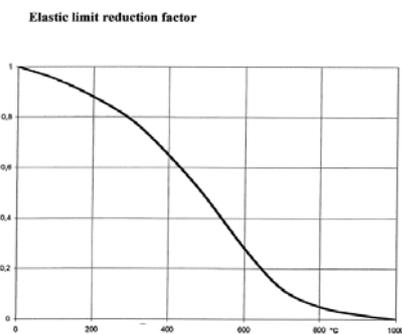
In case of fire, static loaded metal structures are not able to function in a proper way because at high temperature the steel elements fire resistance is very restricted and at 500 oC and above their durability is simply lost.

The objective of the project was to cover the walls and structures in the turbine hall with fire protective insulation layers, which under the influence of high temperatures (above 250 oC) bloat and significantly decrease heat flow from the fire to the protected structures. The aim of the project was to cover the wall and structure surfaces with a layer of coating that would keep the surface temperature within 500 oC for 0.75 h.
